“Air bubble artefact”: a new type of artefact on CT head examinations

¹S McVey, ²A.K. Kanodia, ²S. Dundas

¹Medical Physics Department, Ninewells Hospital, Dundee, UK

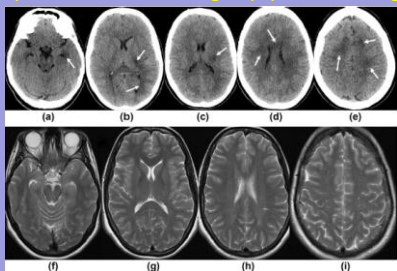
Two patients presented with neurological symptoms and CT demonstrated several ill-defined areas of low attenuation in the cerebral hemispheric white matter (Figure 1: a-e). They then underwent MRI within the next few days. The MRI did not show the changes seen at CT (Figure 1: f-i). It was assumed this was due to a reversible aetiology although the improvement was thought to be too soon. Over the next few days several similar cases presented.

Figure 1 (a-e) Non contrast CT images (f-i) axial T2 images

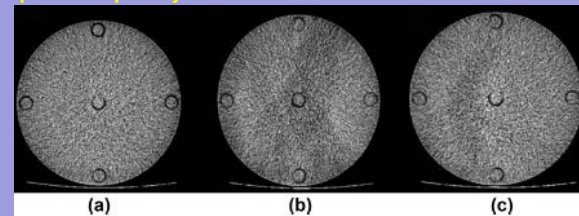
The CATPHAN and CTDI Perspex head phantom images were reviewed. The artefact was not visible on CATPHAN images but was visible on images of the CTDI Perspex head phantom. In this case the motion of the air bubble could be seen as the tube rotated (Figure 3 a-c). This required a narrow window width (40 HU) in order to clearly identify the artefact. Although the artefact was visible the image passed quantitative tests as the tolerance is ± 3 HU. The small variation in CT number due to the air bubble was sufficient to cause the artefact in CT head exams which may then be mistaken for pathology.

Figure 3 (a) No artefact visible (b-c) Artefact visible as air bubbles present in primary beam.

The air bubbles lowered the attenuation of the X-ray beam by < 3 HU. The number of air bubbles were variable and they unpredictably crossed the X-ray beam, explaining the inconsistency in the artefacts. Due to the low level of CT numbers involved this was not identified by quantitative tests and visible only on the window setting used for CT head exams.

The air was removed from the tube oil cooling system by a service engineer.

On a local level, the Level A and Level B QC tests were reviewed. An additional helical acquisition using the clinical CT head protocol on the water filled portion of the GE phantom is included in the weekly QC to be viewed at the full range of window levels and widths. A similar test will be included in Level B tests.
